Direct restorative approach with composite resin in a discolored tooth: a case report

Aim: This case report aimed to discuss the clinical sequence and the indications of the direct veneer technique with composite resin to mask a discolored tooth. **Case report:** A 18-year-old male patient attended a Dental School for treatment of the maxillary central incisors. During the initial examination, the patient reported a dental traumatism in childhood fracturing both teeth. Tooth 21 had already been endodontically treated, and the patient complained of the darkened color, while tooth 11 had been fractured for a long time. **Results:** Poor class IV composite resin restoration was found, showing rests of endodontic material on tooth 21 and class IV dental fracture on element 11. The elements were cleaned, restorative materials were removed and composite resin veneers were made using a silicone guide technique. Finishing and polishing were performed in the next session, reproducing some of the peculiar characteristics of young teeth, consistent with the patient's age, such as macro and microtextures. **Conclusion:** The use of direct veneers in composite resin proved to be efficient to r

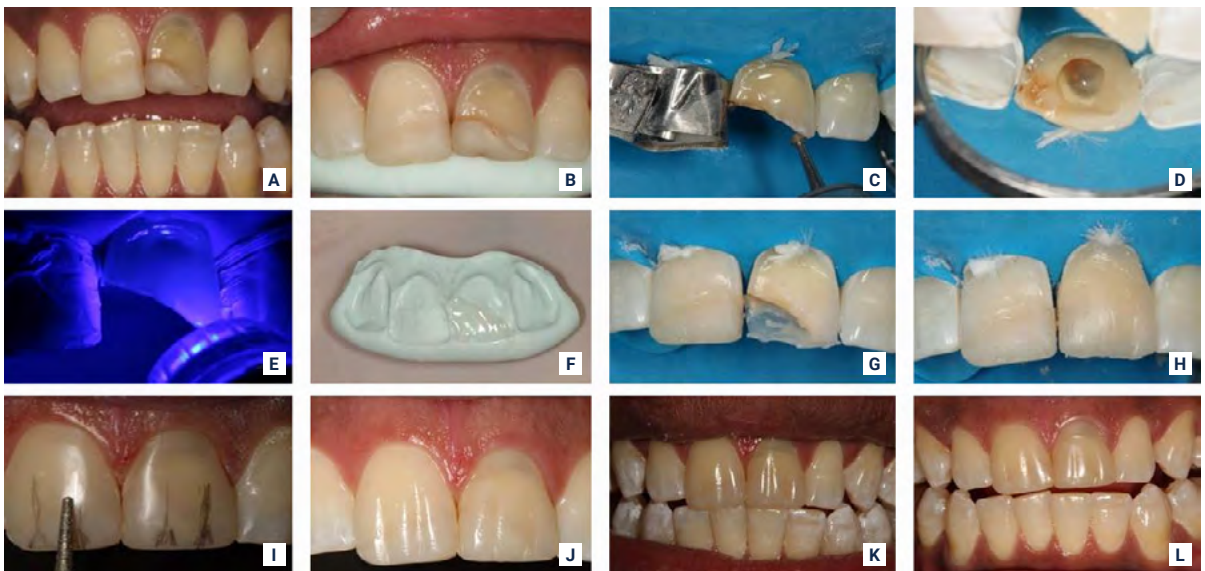
FIGURE 2 - Clinical sequence of procedures. (A) Initial situation. (B) A palatal impression of previous restorations. (C) Dental preparation. (D) Appearance after preparation, with the removal of orthodontic wire that functioned as a post. (E) Application of the adhesive system and photoactivation. (F) Insertion of composite resin in the silicone matrix. (G) Composite resin increment firstly inserted in the palatal face. (H) Surface resin composite increments simulating the enamel. (I) Anatomical characterization of Restoration (finishing and polishing phase). (J) Finished and polished veneers. (K) Immediate result (note the dehydration of the natural dental elements). (L) Aspect in the reevaluation, where a color harmony was observed with the neighboring teeth, but with a discolored cervical area that required reintervention.

The manufacturing of veneers involving unsatisfactory class IV restorations was performed by the silicone wall technique. Thus, using a putty condensation silicone (Perfil™; Coltene, Rio de Janeiro, Brazil), the palatal face of the teeth that were properly shaped was molded (Figure 2b). Then, prophylaxis of the teeth was performed so that the color selection could be made. The trademarks and colors selected were: Brilliant Ever Glow™ OA3 resin (Coltene, Whaledent, Altstätten) for dentin and Filtek Z350™ A2E resin (3M ESPE) for enamel. Then, anesthesia, rubber dam isolation, removal of old restorative materials and orthodontic wire inside the tooth 21 channel were performed (Figure 2c and d). After the preparation, acid conditioning was performed with 37% phosphoric acid for 30 seconds in enamel and 15 seconds in dentin followed by washing for the same time of application and drying with a wet cotton ball. The adhesive system (single bond Universal™-3M ESPE) was applied with a microbrush according to manufacturer's instructions followed by photoactivation (Radii-cal™; SDI, São Paulo, SP, Brazil) for 30 seconds (Figure 2e).

The insertion of the restorative material started with the construction of the palatal wall (Figures 2f and g). Then, a layer of dentin resin was applied and finished with an increment of enamel resin covering the entire buccal surface (Figure 2h).

In another session, the stages of finishing and polishing the restorations were carried out, reproducing some of the peculiar characteristics of young teeth, consistent with the patient's age, such as macros and microtextures (Figure 2 i-l).
